MEASUREMENT OF FLYING QUALITIES OF A DEHAVILLAND

MOSQUITO F-8 AIRPLANE (AAF NO. 43-334960)

I - LATERAL AND DIRECTIONAL STABILITY

AND CONTROL CHARACTERISTICS

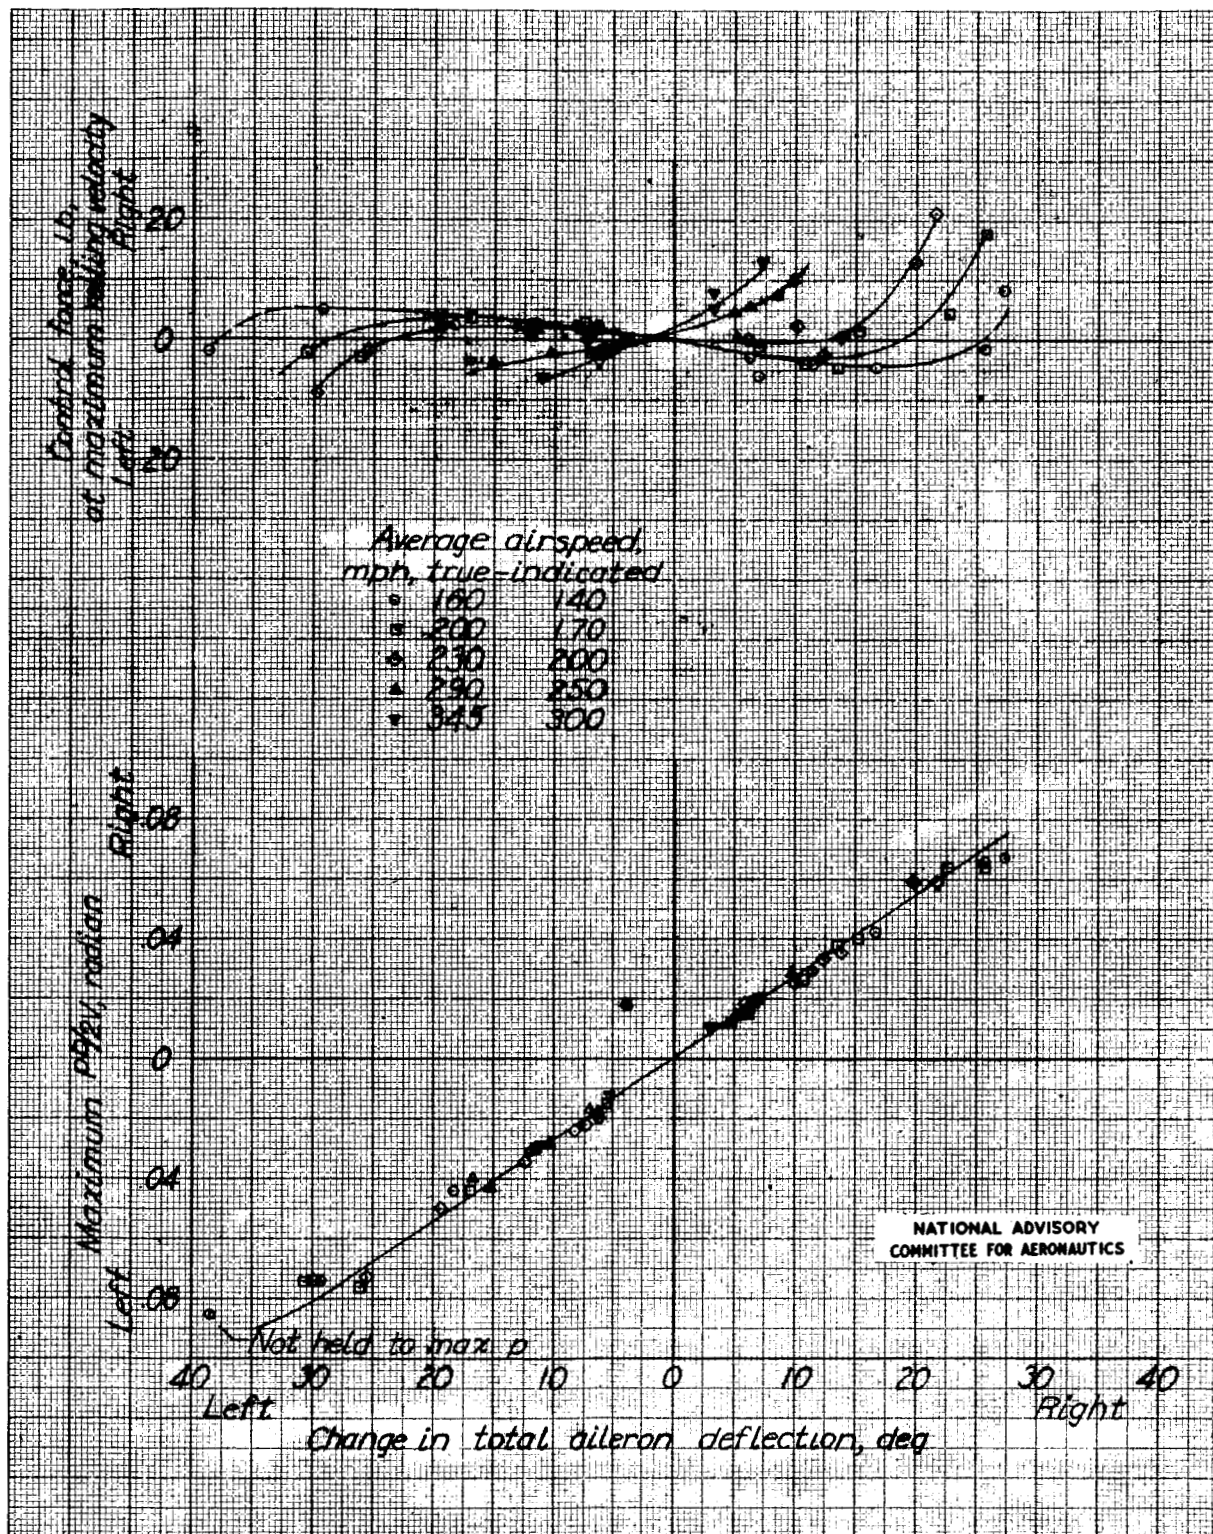
Figure 26. - Variation of aileron control force and effectiveness with total aileron deflection in the clean condition at various speeds using power for level flight or rated power, DeHavilland Mosquito F-8 airplane.

figures 25 through 28 indicate that on this particular Mosquito aileron overbalance occurred in rolls in all conditions below 200 miles per hour over a considerable range of aileron deflections. It has been stated previously that the ailerons tended to shake when fully deflected and that an example of aileron shaking is presented in figure 10(c).

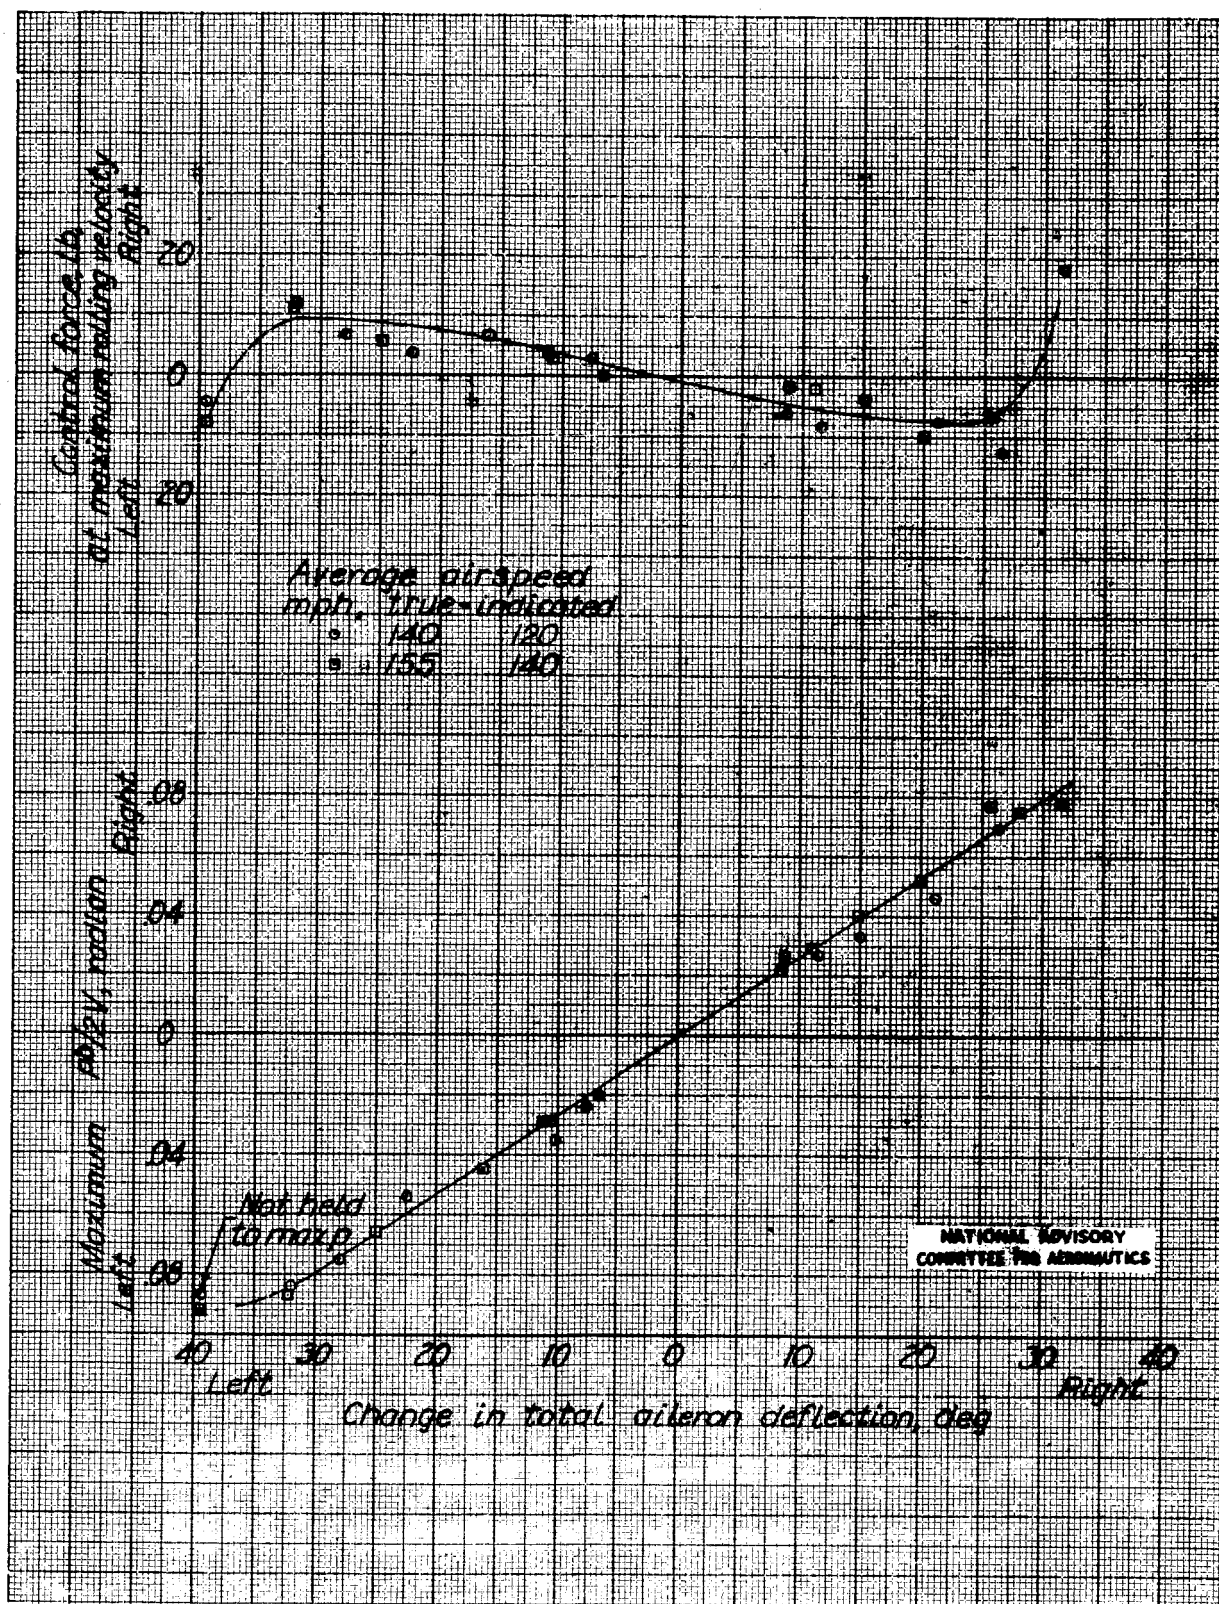
Figure 27. - Variation of aileron control force and effectiveness with total aileron deflection at 120 and 140 miles per hour with flaps down, landing gear down, and engines idling, DeHavilland Mosquito F-3 airplane.

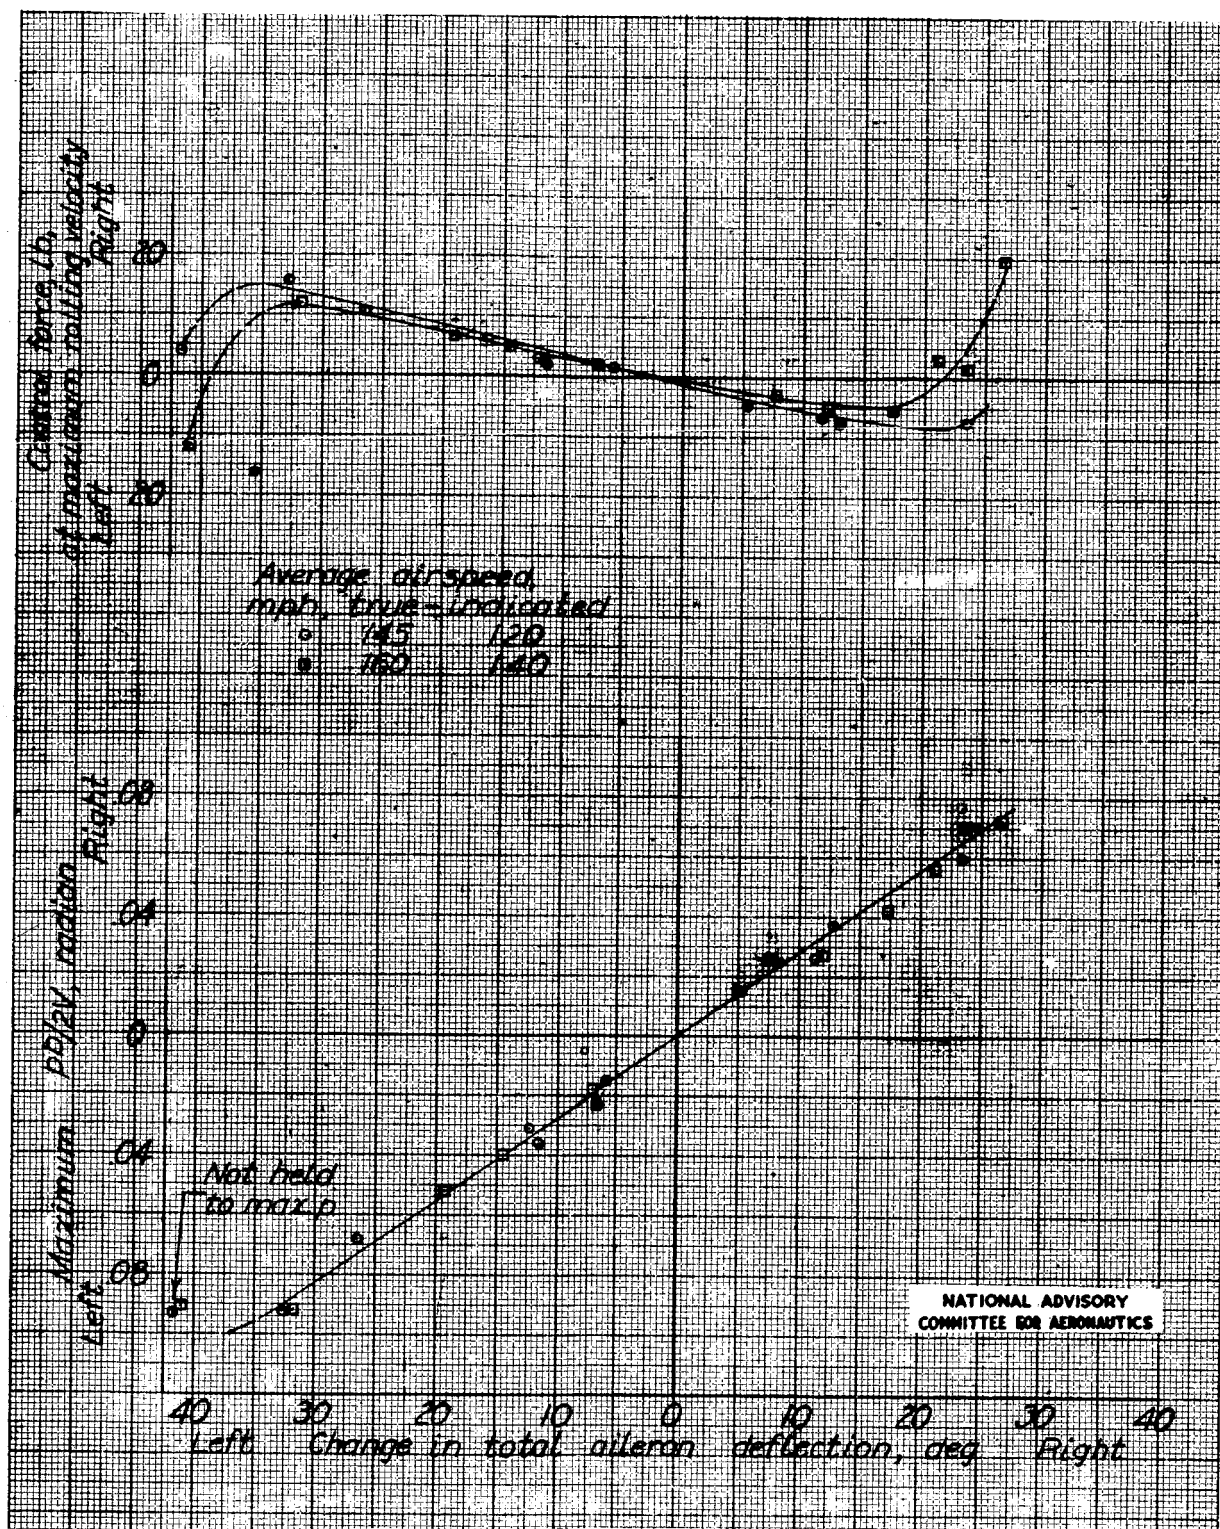
Figure 28, - Variation of aileron control force and effectiveness with total aileron deflection at 120 and 140 miles per hour with flaps down, and landing gear down using power for level flight, DeHavilland Mosquito F-5 airplane.
